Technical Service Bulletin # 11

Product: **Incubator 8000 IC / SC / NC**

Re: **New hinge brackets for front flap**

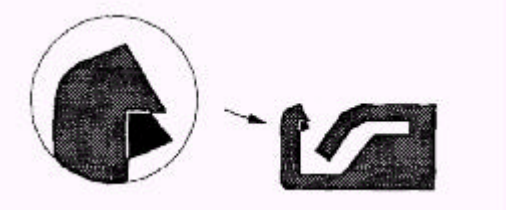
Reason: With the blue front-flap hinges as of mid 94, one-handed opening of the flap can result in hinge becoming detached from hinge bracket. The second hinge cannot hold the flap and may break.

Old, with or without plate

New, without plate

Solution: Replacement with new version of hinge bracket 2M 19 542.
